Report No. CG-D-01-99, II

**Investigation of Fuel Oil/Lube Oil Spray Fires
On Board Vessels**

Volume II

Incident Databases

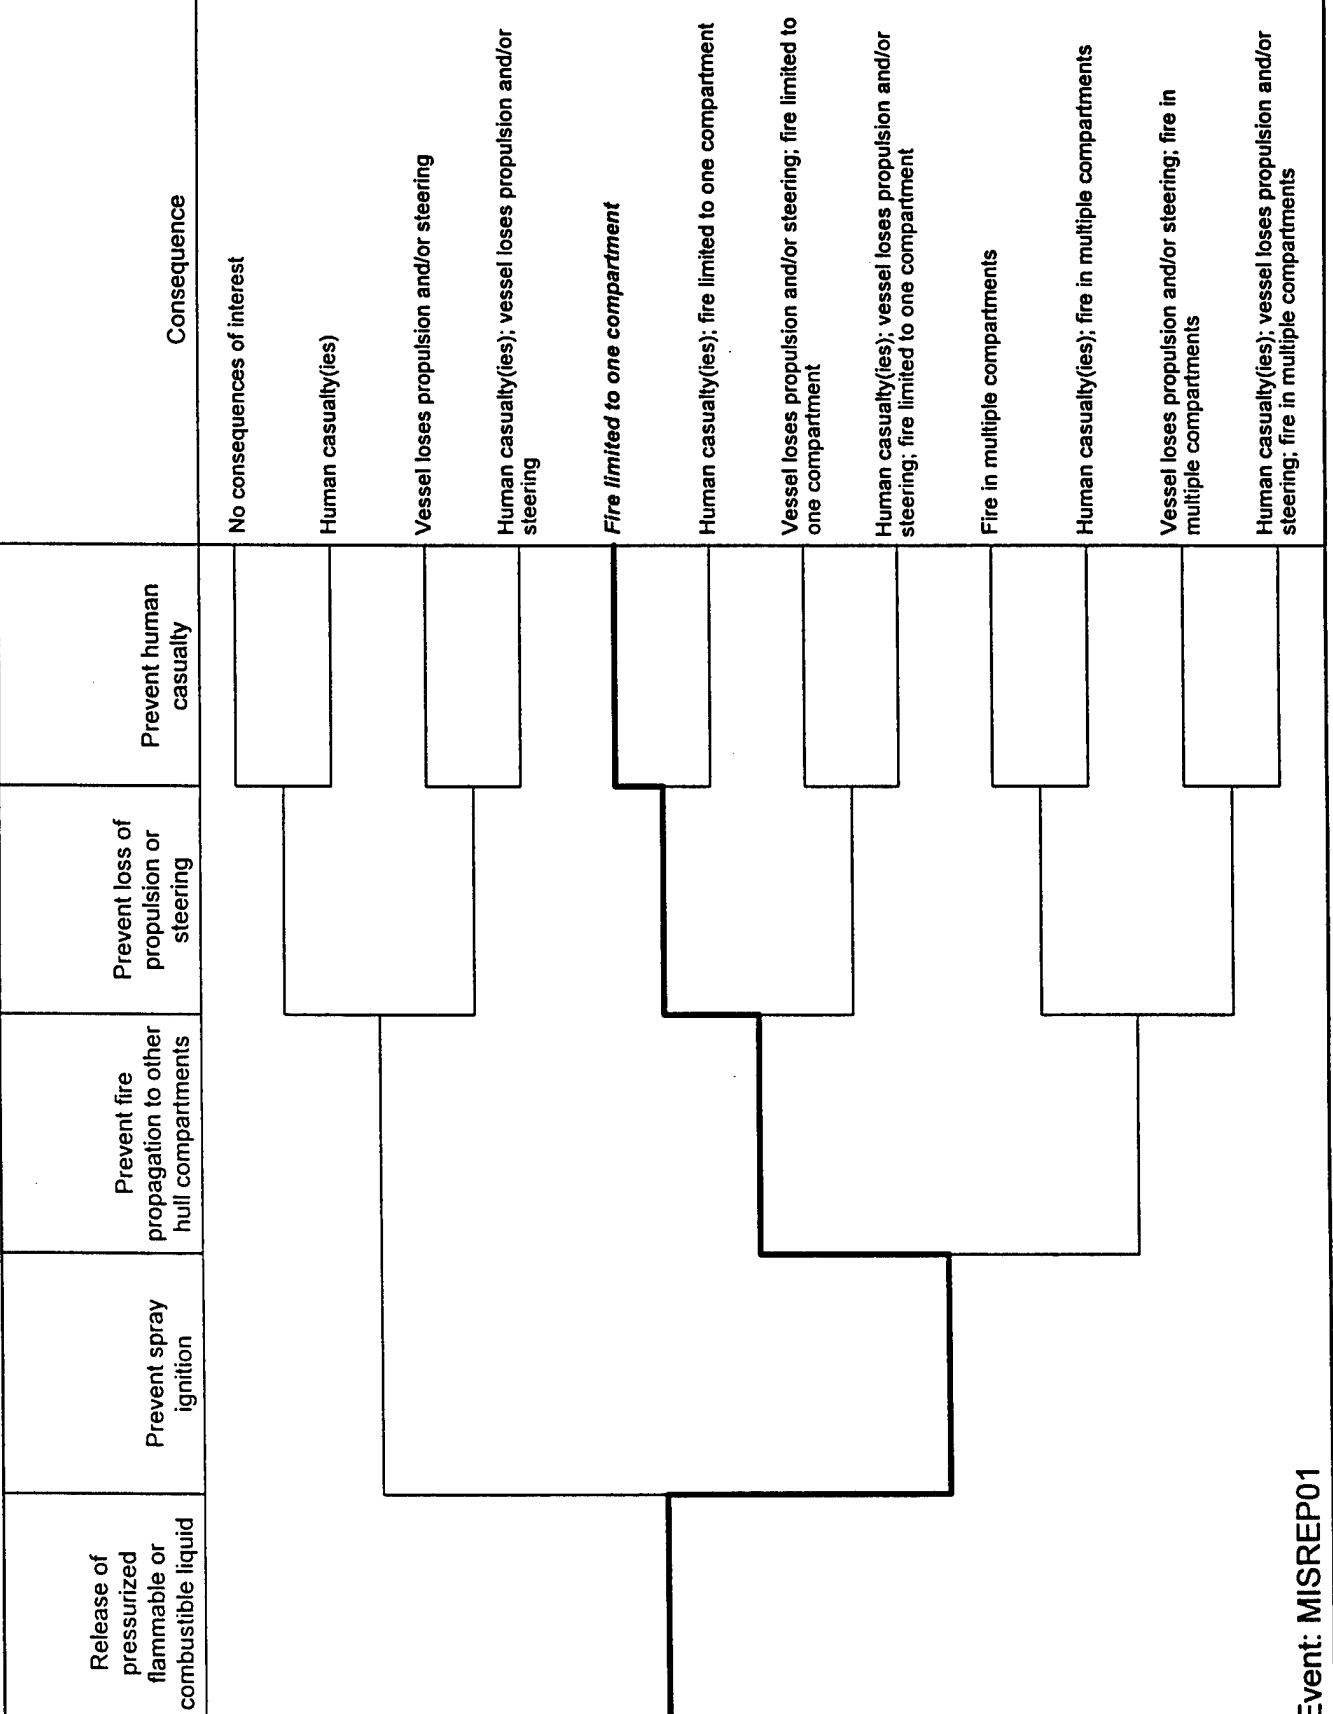
Event: MISREP01

DESCRIPTION	ACTIONS	CAUSES
WHILE ATTEMPTING TO START CG191500 TO GET UNDERWAY FOR A SAR MISSION, THE STBD ENGINE CAUGHT ON FIRE. IT WAS DETERMINED THAT THE HOSES FOR THE CHOKE HAD BEEN PULLED OFF ON THE ENGINE SIDE.	FIRE WAS PROMPTLY PUT OUT WITH A CO2 FIRE EXTINGUISHER, HOSES WERE REPLACED.	POSSIBLE DESIGN FAULT. WHEN PULLING COVER OFF OF OUTBOARD THIS HOSE IS SUSCEPTIBLE OF CATCHING ON THE COVER LATCH.

Event Number: 5628 (MISREP01)	Event Characterization	
	As Documented in the Event Report	As Inferred from the Event Report
System/Location	Fuel oil/engine room	
Cause	Cover latch suspected of having caught the hoses for the choke and pulled them off. This may have been a design flaw	
Ignition Source		Hot surface
Detection		Crew
Release Isolation		Crew shut off the engine, which shuts off the fuel pump
Fire Suppression	CO ₂ extinguisher	
Impact on Propulsion		This event would have caused partial loss of propulsion (crew was attempting to start the engine to get under way)
Impact on Steering		None
Human Casualty		None
Corrective Action to Prevent Recurrence	No preventive action mentioned – hoses were replaced

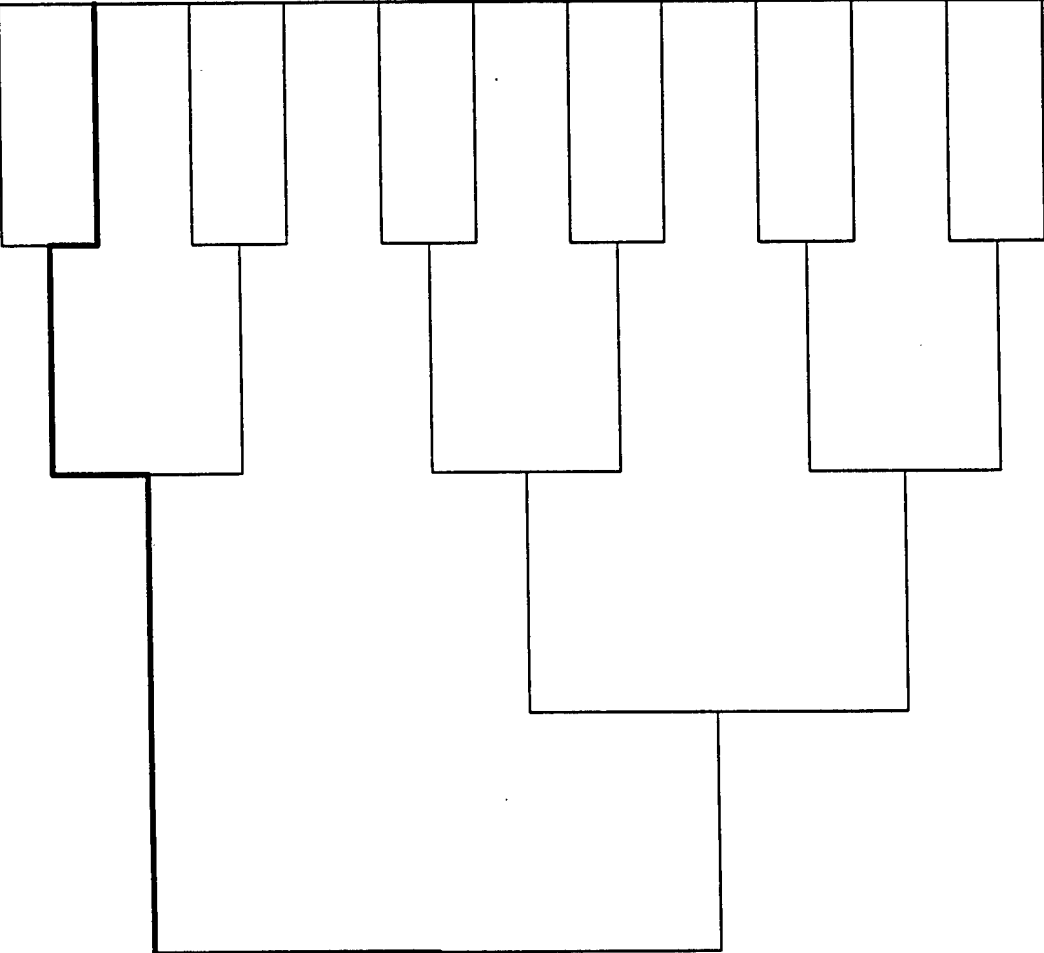
Event: MISREP09

DESCRIPTION	ACTIONS	CAUSES
<p>MAJOR FUEL OIL LEAK. NO. 2 MDE FUEL FILTER/COALESCER HAD JUST BEEN SHIFTEDFROM AFT TO FORWARD. AN FA AND AN FN WERE ASSIGNED TO ISOLATION THE AFTCOALESCER FROM THE FORWARD COALESCER. HOWEVER, THE BALL OF THE TOP VALVE WASSLIGHTLY OPEN. ALSO, THE HANDLE WAS WORN. THE FA AND FN THOUGHTST THEY WEREDRAINING THE COALESCER AS WELL AS RELEASING ALL REMAINING PRESSURE BY OPENINGTHE BOTTOM DRAIN VALVE. THEY BEGAN TO REMOVE THE TOP COVER WHEN OIL BEGANSPRAYING. BOTH CREWMEMBERS WERE SOAKED WITH FUEL, AND SPRAYED IN THE EYES. THEFA DEFLECTED THE FUEL SPRAY INTO THE BILGE WITH HIS GANDS UNTIL THE ENGINE WASSECURED. GENERAL EMERGENCY WAS SET AND BILGES WERE COVERED WITH AFFF.APPROXIMATELY 30 GALLONS OF FUEL OIL WERE LOST. NO DAMAGE TO EQUIPMINTOCCURRED.</p> <p>This event was also documented as event 93223002 as follows:</p> <p>MAJOR FUEL OIL LEAK. NO 2 MDE FUEL FILTER/COALESCER HAD JUST BEEN SHIFTEDFROM AFT TO FORWARD. A FIREMAN AND A FIREMAN APPRENTICE WERE ASSIGNED TOCHANGE THE AFT FILTER. VALVE HANDLES WERE ALIGNED PROPERLY, ISOLATING THE AFTCOALESCER FROM THE FORWARD COALESCER. HOWEVER, THE BALL OF THE TOP VALVE DIDNOT COMPLETELY ROTATE WITH THE HANDLE, LEAVING THE VALVE SLIGHTLY OPEN. THEHANDLE WAS WORN. THE FN AND FA THOUGHT THEY WERE DRAINING THE COALESCER ASWELL AS RELEASING ALL REMAINING PRESSURE BY OPENING THE BOTTOM DRAIN VALVE.THEY BEGAN TO REMOVE THE TOP COVER WHEN OIL BEGAN SPRAYING. BOTH CREW MEMBERSWERE SOAKED WITH FUEL. THE FA DEFLECTED THE FUEL SPRAY INTO THE BILGE WITHHIS HANDS UNTIL THE ENGINE WAS SECURED ...</p>	<p>PERSONNEL WILL WEAR PROPER EYE PROTECTION AND GLOVES WHEN SHIFTING COALESCERS.*****</p> <p>This event was also documented as event 93223002 as follows:</p> <p>NONE.*****</p>	<p>PERSONNEL ERROR; CREWMEMBERS WERE NOT WEARING PROPER EYE PROTECTION. ALSO THEYSHOULD HAVE VENTED PRESSURE FROM THE TOP VENT PLUG AS WELL AS THE BOTTOM DRAINVALVE. THIS WOULD HAVE REVEALED THAT THE SYSTEM WAS STILL PRESSURIZED.****</p> <p>This event was also documented as event 93223002 as follows:</p> <p>PERSONNEL ERROR: THE FIREMEN SHOULD HAVE VENTED THE PRESSURE FROM THE TOPVENT PLUG AS WELL AS THE BOTTOM DRAIN VALVE. THEY ALSO SHOULD HAVE WORNSAFETY GOGGLES AND DUEL HANDLING GLOVES IAW PMS M-C-003. IN ADDITION, THEYSHOULD HAVE TAKEN THE PMS CARD TO THE SCENE AND FOLLOWED THE LISTEDPROCEDURES.**</p>

Event Number: 93193011 and 93223002 (MISREP09)	Event Characterization	
	As Documented in the Event Report	As Inferred from the Event Report
System/Location	Fuel oil/engine room	
Cause	Personnel error (crew should have vented pressure from the top vent plug as well as the bottom drain valve to reveal that the system was pressurized). Also, crew should have (1) worn goggles and fuel gloves, (2) taken the PMS card to the scene, and (3) followed the listed procedures	
Ignition Source	No ignition occurred	
Detection		Crew present at release location during occurrence
Release Isolation	Engine was "secured"	
Fire Suppression		None required - no fire
Impact on Propulsion	None	
Impact on Steering	None	
Human Casualty	Fuel oil sprayed into eyes of crew members	
Corrective Action to Prevent Recurrence	The report states that crew will wear proper eye protection and gloves when shifting coalescers. (The report does not mention how this will be ensured)

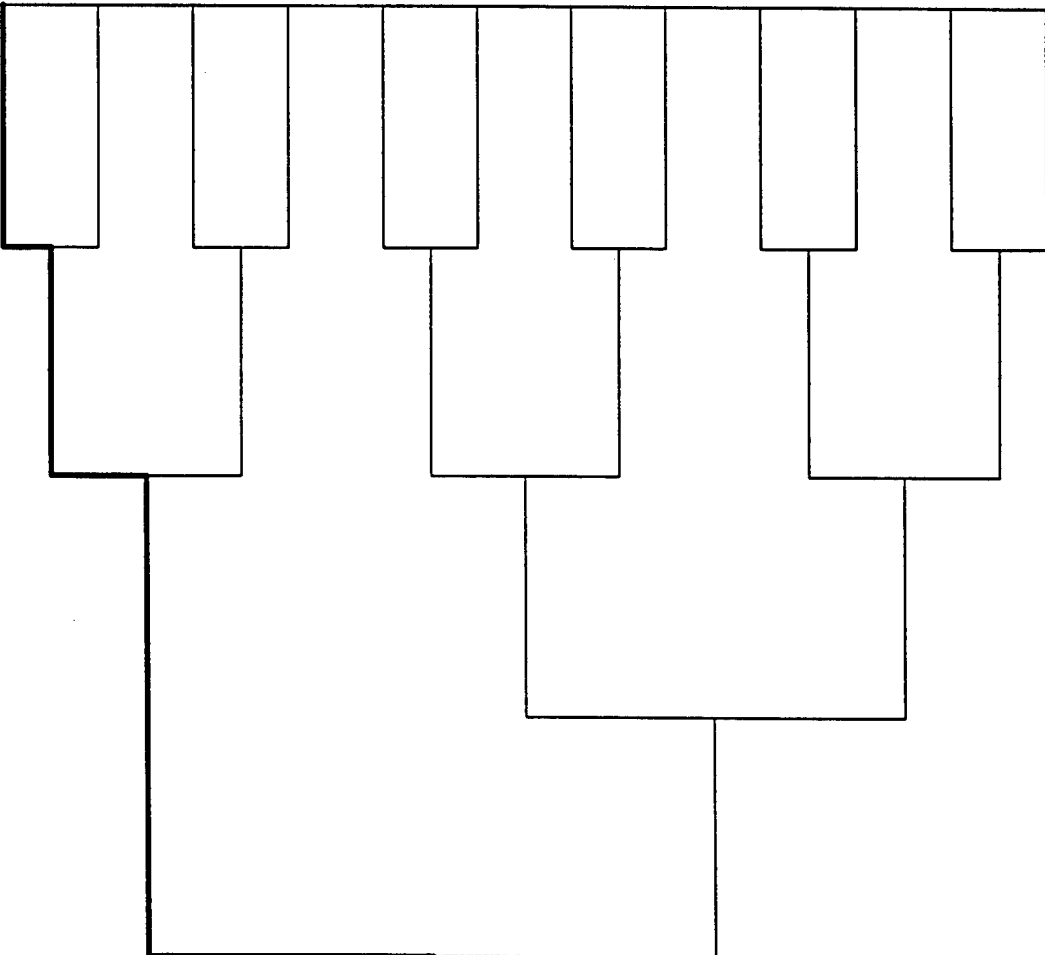
Event: MISREP10

DESCRIPTION	ACTIONS	CAUSES
WATCH RELIEFS ENTERED ENGINE ROOM AND NOTED A STRONG ODOR OF DIESEL FUEL. THERE WAS FOUND TO BE A LEAK IN THE FILTER BANK OF NO.1 MDE, THE CAP NUT FOR ONE FILTER ASSEMBLY BACKED OFF CAUSING THE CAP TO LEAK. APPROX 2 GALLONS OF FUEL WERE SPILLED THAT WERE SUBSEQUENTLY WIPED UP BY SHIP'S FORCE.	ENSURE CAP NUTS ARE TIGHTENED ACCORDING TO MANUFACTURER'S SPECIFICATIONS. CONDUCT FREQUENT CHECKS OF THE CAP NUT WHILE IN SERVICE.*****	CMPROPER TIGHTENING TORQUE FOR FILTER CAP NUT.*****

Event Number: 93195011 (MISREP10)	Event Characterization	
	As Documented in the Event Report	As Inferred from the Event Report
System/Location	Fuel oil/engine room	
Cause	The cap nut for one filter assembly backed off, causing the cap to leak. Approximately 2 gallons of fuel was spilled. The cap nut backed off because of improper tightening	
Ignition Source		No ignition occurred
Detection	Crew (watch reliefs) noticed strong odor	
Release Isolation		Replaced cap on filter assembly
Fire Suppression		None required - no fire
Impact on Propulsion		None
Impact on Steering		None
Human Casualty		None
Corrective Action to Prevent Recurrence	Ensure cap nuts are tightened according to manufacturer's specifications Conduct frequent checks of the cap nuts while in service

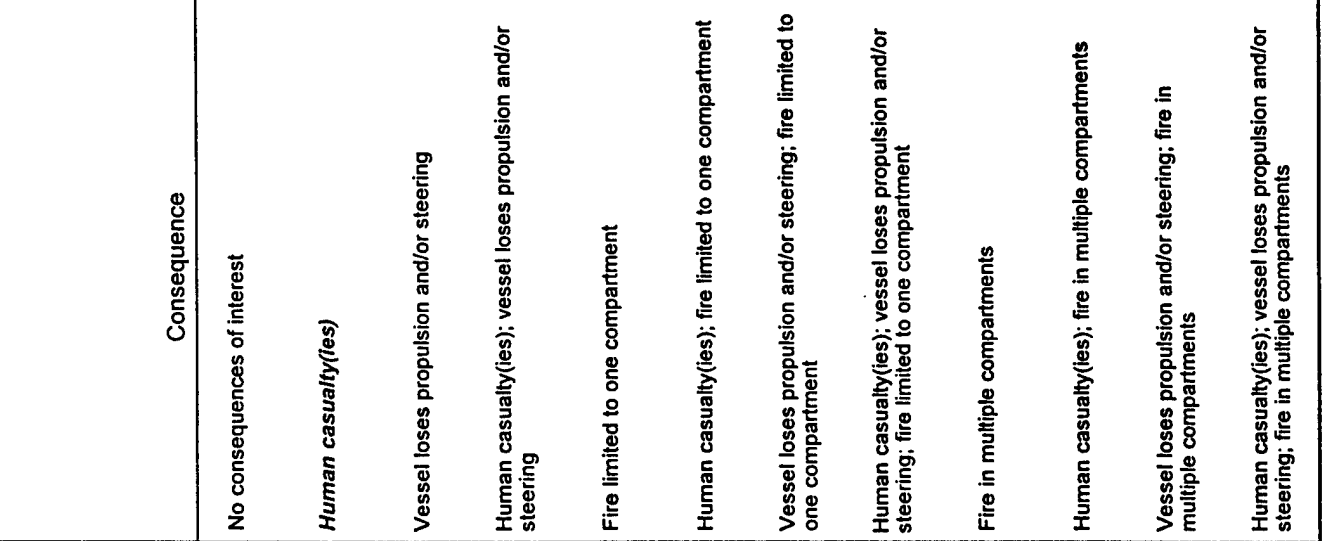
Event: MISREP18

DESCRIPTION	ACTIONS	CAUSES
<p>MEMBER A AND MEMBER B WERE ASSIGNED TO FIX A LEAK IN THE MESSDECK HEATER LINE. HEATER SYS HAD TO BE FLUSHED FREE OF FLUID TO REPAIR MESSDECK HEATER. MEMBER B DISCONNECTED THE RETURN LINE TO THE ENGINE AT THE VALVE AND LEFT RETURN VALVE OPEN SO FLUID WOULD DRAIN INTO THE BILGE. SUPPLY LINE WAS LEFT CONNECTED AND VALVE OPEN. WHILE THESE MEMBERS WORKED, AN INSPECTION WAS BEING DONE BY MEMBER C AND VISITING MEMBER D. MEMBER A HAD DISCONNECTED THE SUPPLY LINE FROM THE MESSDECK HEATER AND HAD AN AIRHOSE WITH APPROX 100 PSI SUPPLIED TO IT. THEY WERE READY TO FLUSH THE SYS. MEMBER A PRESSURIZED THE SYS WITH AIR, MEMBERS C AND B OBSERVED THE SYS PRESSURIZE AND STARTED TO SPRAY ETHYLENE GLYCOL FROM THE EXPANSION TANK OVERFLOW TUBE AND RETURN LINE AT THE BASE OF THE ENGINE, WHICH WAS DISCONNECTED FROM THE RETURN VALVE AND POINTED UP. MEMBER C TOLD MEMBER B TO SECURE SUPPLY VALVE TO ENGINE. AS HE SECURED VALVE HE WAS SPRAYED IN EYES AND ON CLOTHES. MEMBER B WAS LED TO AN EMERG EYE WASH STATION AND ASSISTED BY A STATION EMT AND LATER BROUGHT TO THE LOCAL HOSPITAL ER.</p>	<p>MEMBERS A AND B WERE COUNSELED ON THE PROPER PROCEDURES FOR THIS JOB. THE IMPORTANCE OF SAFETY GEAR HAS BEEN STRESSED. A LOW PRESSURE NOZZLE (UP TO 30PSI) HAS BEEN PURCHASED TO USE.</p>	<p>THERE ARE THREE ERRORS WHICH LED TO MISHAP: 1. THERE WAS NO USE OF SAFETY GEAR (EYE PROTECTION). 2. THE SUPPLY VALVE TO THE ENGINE WAS LEFT OPEN, CAUSING FRESH WATER SYS TO CIRCULATE AND EMPTY OUT OF THE DISCONNECTED RETURN LINE. 3. THE AIR PRESSURE USED WAS EXCESSIVE FOR THIS JOB.</p>

Event Number: 94031001 (MISREP18)	Event Characterization	
	As Documented in the Event Report	As Inferred from the Event Report
System/Location	Heater system/deck	
Cause	Crew was flushing all liquid from the system to repair a leak. One crew member used 100-psig air supply to help purge the system, but other members observed ethylene glycol spraying out the overflow tube for the expansion tank. While attempting to stop the spray, a crew member was sprayed in the eyes and on clothing	
Ignition Source		No ignition occurred
Detection		Crew
Release Isolation		Crew secured air supply
Fire Suppression		None required - no fire
Impact on Propulsion		None
Impact on Steering		None
Human Casualty	One crew member was sprayed in the eyes and was taken to the emergency room at a local hospital	
Corrective Action to Prevent Recurrence	Crew members were counseled on the proper procedures for this activity. The importance of wearing safety gear was stressed. Also, a low pressure nozzle (about 30 psig) was purchased to use during similar activities

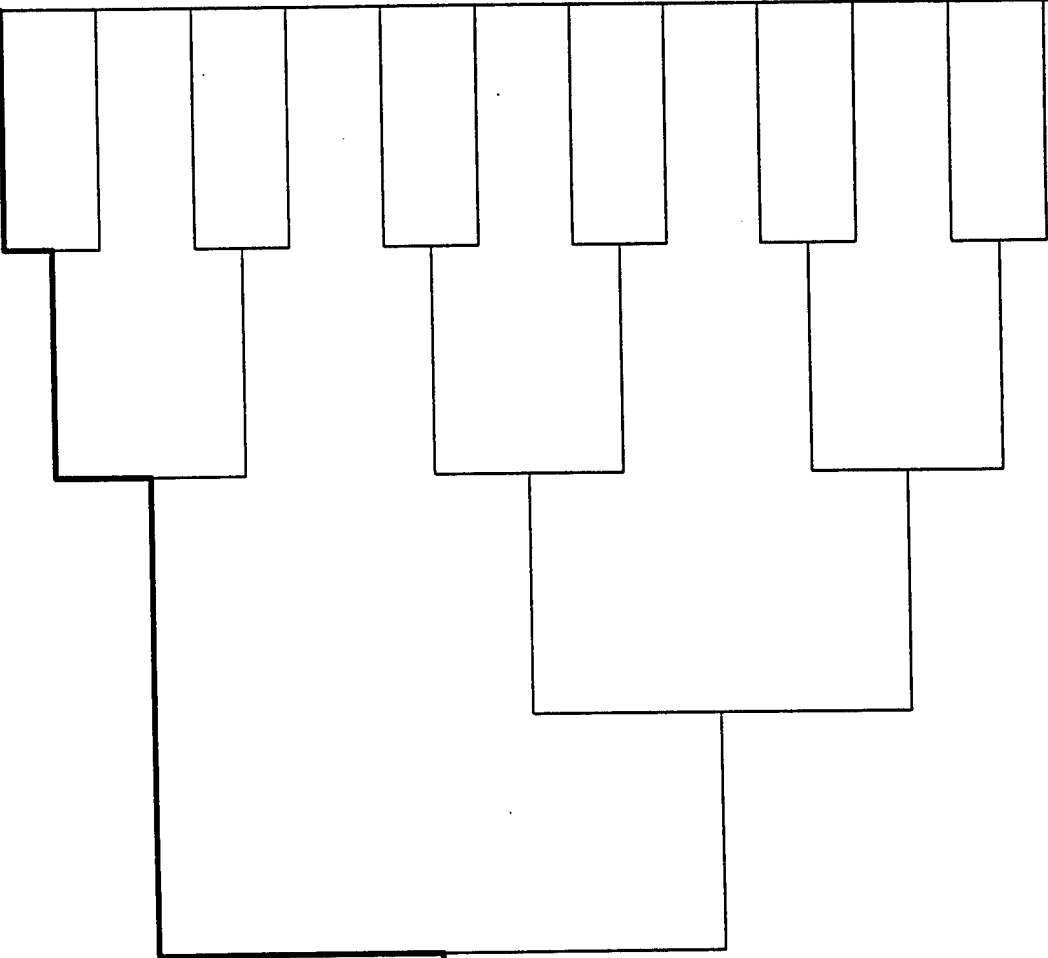
DESCRIPTION	ACTIONS	CAUSES
Unit was underway with #1 main diesel engine in M/P loop pilot house control with approx. 80 shaft turns. U/W oiler was making a round in the engine room when he noticed a small fuel oil leak coming from the return line on #1 MDE. He immediately notified the OOD. The vessel was brought to full stop, #2 was started and placed on line. #1 MDE was secured. The source of the leak was located. Approx. 3-4 drops of f/o per second dripped into the bilges.	Support Center Boston repaired pipe. Rubber mounting bracket was installed to prevent chaffing. *****	Return line (f/o) and a c/o line rubbed together due to vibration and ship motion. A small pin hole developed. These lines are located in original installed positions. Leading one to believe they are as designed. *****

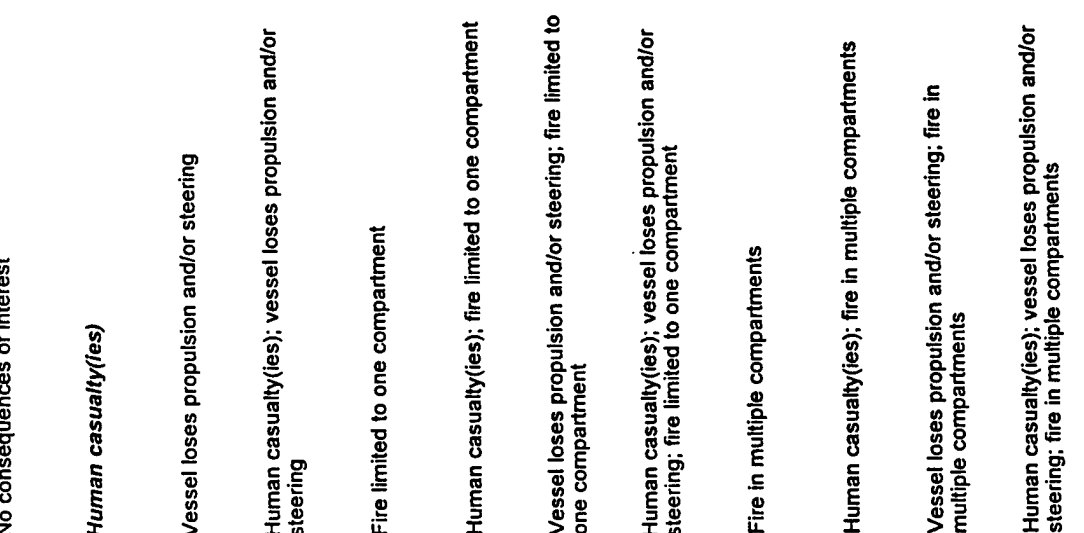
Event: MISREP49

DESCRIPTION	ACTIONS	CAUSES
ON 18APR96 CGC LEGARE AND NESU PORTSMOUTH PERSONNEL WERE CONDUCTING AN OPERATIONAL TEST OF THE NEWLY REBUILT #2 SSDG. WHILE ACTING AS ONE OF MANY OBSERVERS, MK3 ROUSE WAS EXPOSED TO A LARGE AMOUNT OF 9250 LUBE OIL. THIS LUBE OIL LEAKED UNDER PRESSURE WHEN A L/O FILTER HOUSING FRACTURED. THE OIL SPRAY GOT IN HIS EYES AND ON HIS HAIR AND CLOTHING. MK3 ROUSE WAS IMMEDIATELY ESCORTED TO THE ENGINE ROOM EYE WASH STATION AND THE HS1 WAS CALLED TO THE ENGINE ROOM TO RENDER ASSISTANCE.	THE SHOP PERSONNEL ARE GOING TO CAREFULLY LABEL ALL OF THE F/O PUMPS WITH THE PROPER ENGINE APPLICATION. AS WELL, THE PUMPS WITH NO INTERNAL RELIEF VALVE ARE BEING PHASED OUT.	THE CAUSE OF THIS MISHAP WAS THE INSTALLATION OF AN IMPROPER L/O PUMP ON THE #2SSDG. THE PUMP INSTALLED HAD NO INTERNAL RELIEF VALVE WHICH CREATED A HIGH PRESSURE WITH NO RELIEF SITUATION. THE FILTER HOUSING IS NOT DESIGNED TO WITHSTAND THE HIGH PRESSURE, SO IT FAILED. THE CORRECT PUMP LOOKS VERY SIMILAR TO THE INCORRECT PUMP, AND BOTH CAN BE INSTALLED ON THE ENGINE.

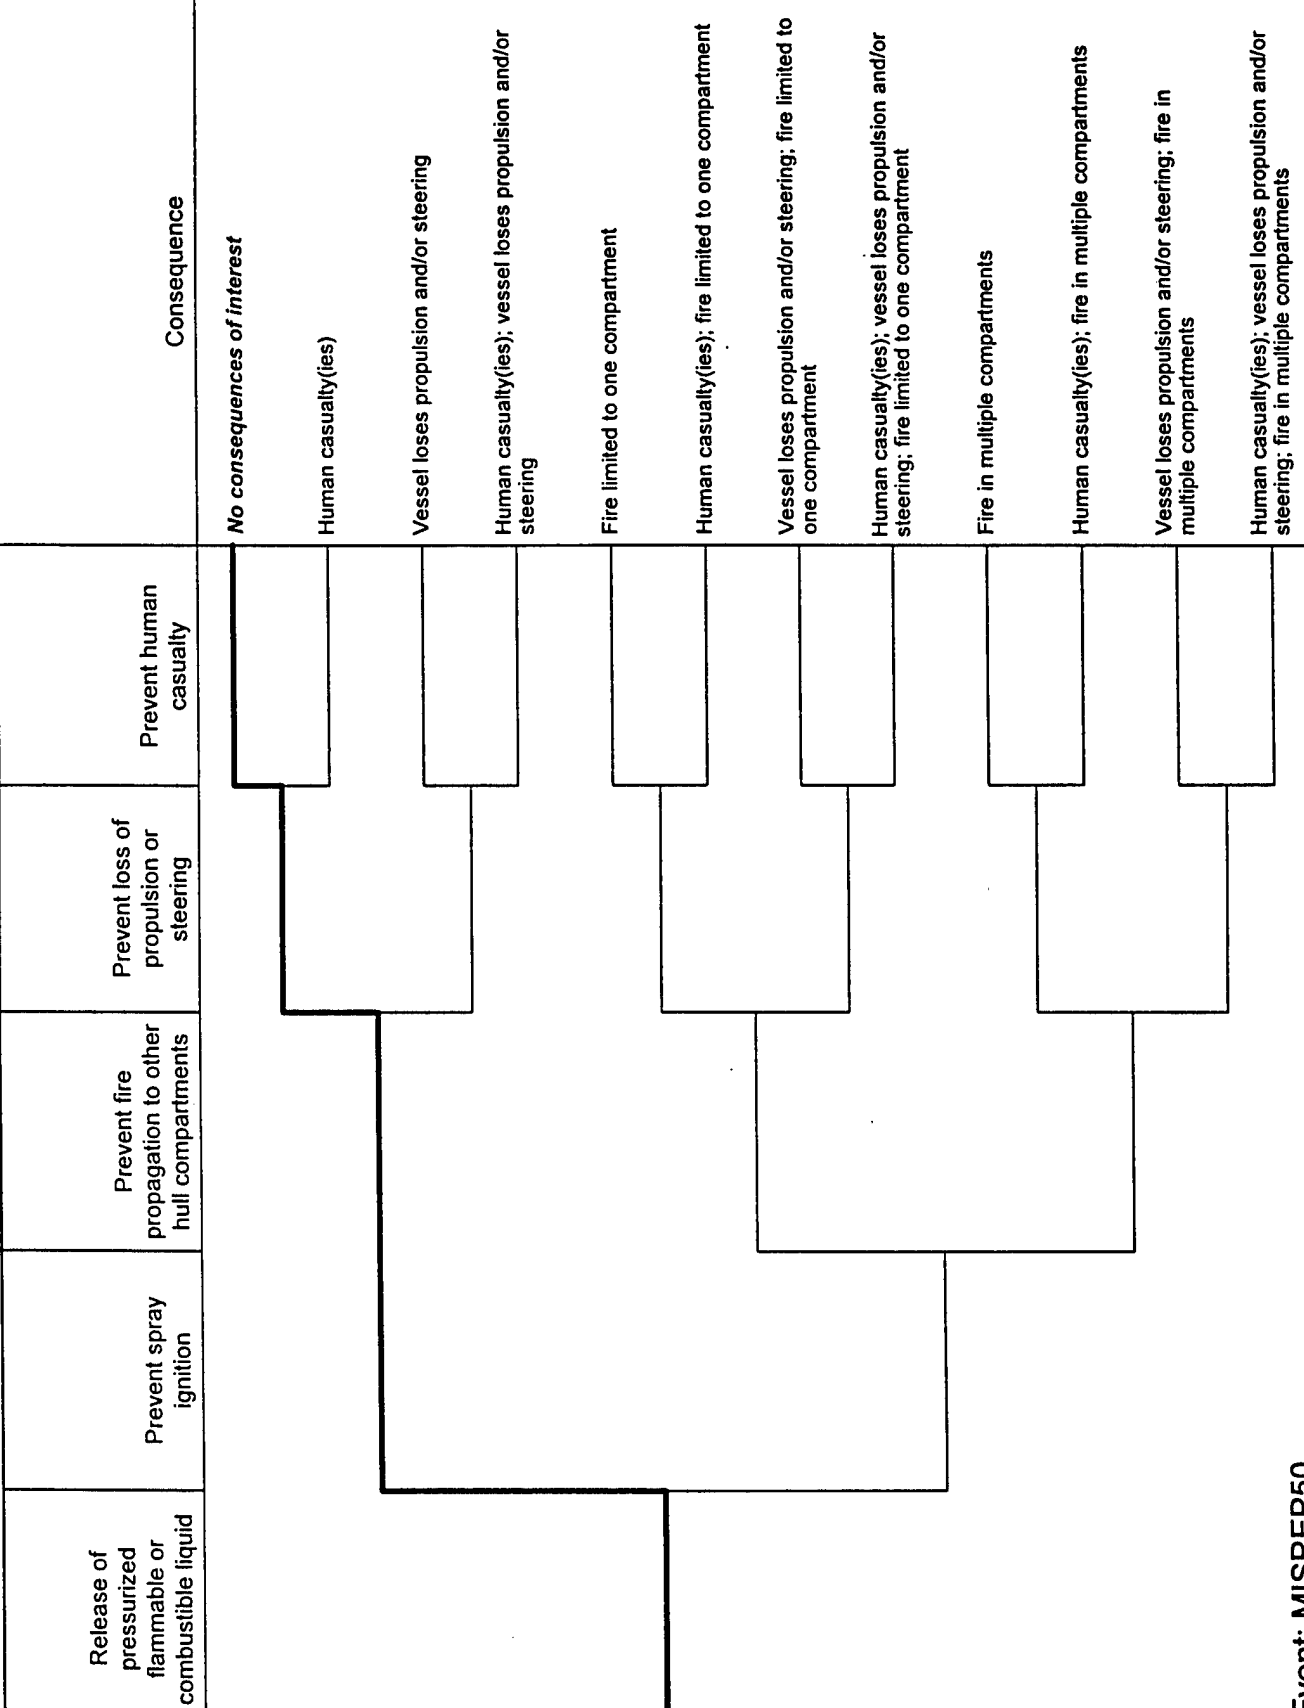
Event: MISREP50

DESCRIPTION	ACTIONS	CAUSES
LOW FUEL OIL PRESSURE ALARM SOUNDED ON THE MPCMS CONSOLE FOR 1 MDE. ENGINE ROOM WATCHSTANDER INVESTIGATED FUEL OIL COALESCER FILTERS AND FOUND VALVE OPEN AND PIPE CAP OFF THE DRAIN LINE OF THE ON-LINE FILTERS. EOW PROCEEDED IAW THE MAIN SPACE FIRE DOCTRINE, AND THE SHIP WENT TO GENERAL QUARTERS. THE ESTIMATED TWO GALLONS OF FUEL OIL WAS COVERED WITH AFFF AND PUMPED TO OIL WASTE TANK.	HOLD DIVISIONAL TRAINING ON PROPER MAINTENANCE PROCEDURES AND QUALITY ASSURANCE.	INATTENTION OF PERSONNEL RENEWING THE FUEL OIL COALESCER AND LACK OF QUALITY ASSURANCE BY SUPERVISORS LED TO THE DRAIN VALVE NOT BEING CLOSED AND THE DRAIN CAP NOT PROPERLY TIGHTENED ON THE COALESCERS DURING THE LAST INPORT. □

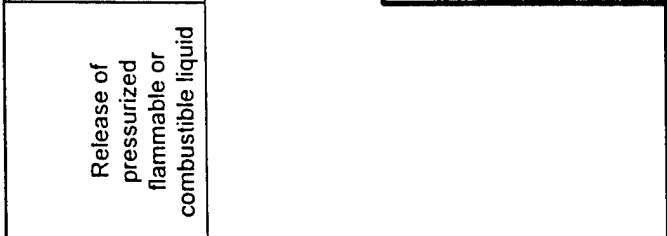
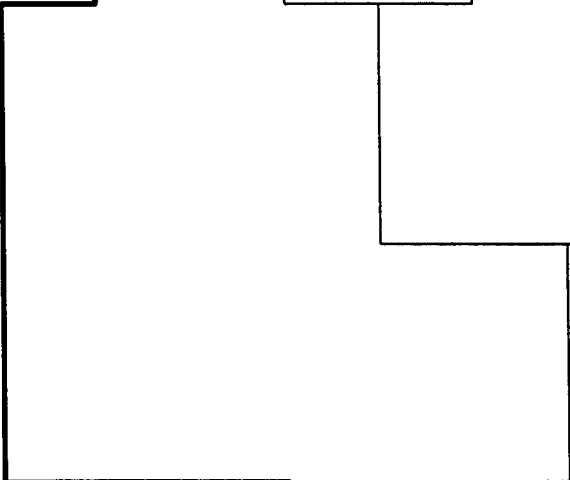
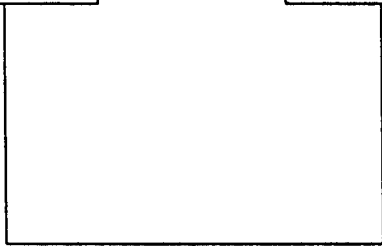
Event: MISREP55

DESCRIPTION	ACTIONS	CAUSES
ENGINE ROOM REPORTED MAJOR FUEL OIL LEAK ON #1 MDE AND RECOMMENDED SETTING GENERAL EMERGENCY IAW CASUALTY CONTROL MANUAL. GENERAL EMERGENCY STATIONS SET AT 1127 IAW MAIN SPACE FIRE DOCTRINE. MATERIAL CONDITION ZEBRA WAS SET. REPORTS FROM ENGINE ROOM INDICATED TWO GALLONS OF NUMBER 2 FUEL OIL SPRAYED FROM #1 MDE COALESCERS ACROSS LOWER LEVEL INBOARD ONTO #2 MDE HOT L/O PIPING. COALESCARS ISOLATED AND BOTH MDE'S SECURED IAW MSFD. WASHED FUEL OIL TO BILGES WITH HOT WATER AND PERFORMED BILGE CLEANUPS USING OIL ABSORBENT PADS. AFTER CLEANUP, STARTED AND PLACED #2 MDE ON LINE. A: SYSTEMS SATISFACTORY. REPAIR LOCKER AND DC CENTRAL SECURED FROM GENERAL EMERGENCY STATIONS AT 1227.	DURING PRIOR MAINTENANCE AND FILTER CHANGE OUTS ENGINEERS DISCOVERED THIS PROBLEM. NEW COALESCAR UNIT WERE ORDERED ON 16 APR 96 AND HAVE NOT BEEN RECEIVED.	#1 MDE COALERS CER TOP COVER GASKET WAS FOUND DEFORMED AND CUT. THIS OCCURED BECAUSE THE ALUMIUM CANISTER IS OUT OF ROUND AND THE BRASS TOP COVER IS NOT; THEREFORE THE PARTS DO NOT ALIGN WHEN TIGHTENED. BOTH COALESCAR CANISTERS FOR #1 MDE ARE OUT OF ROUND.

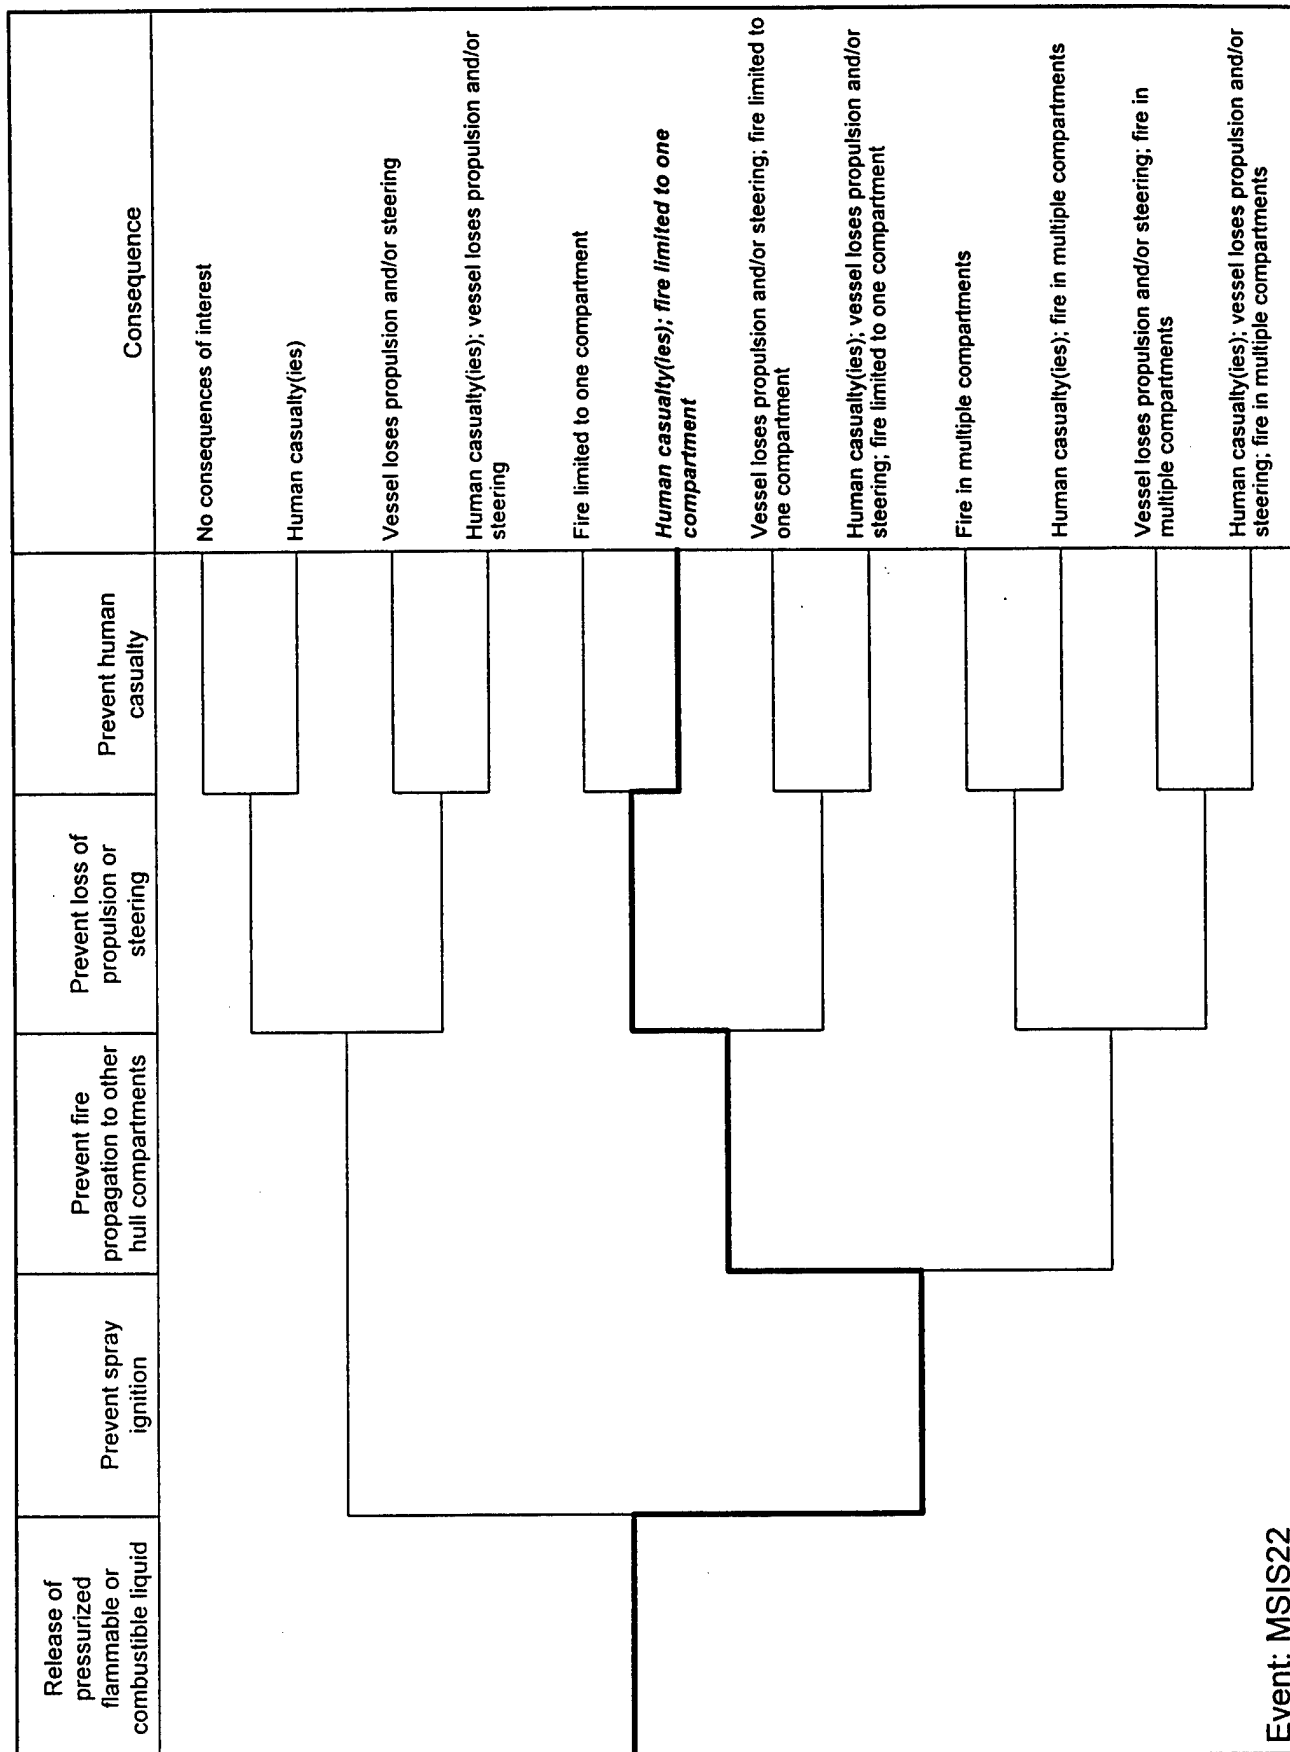
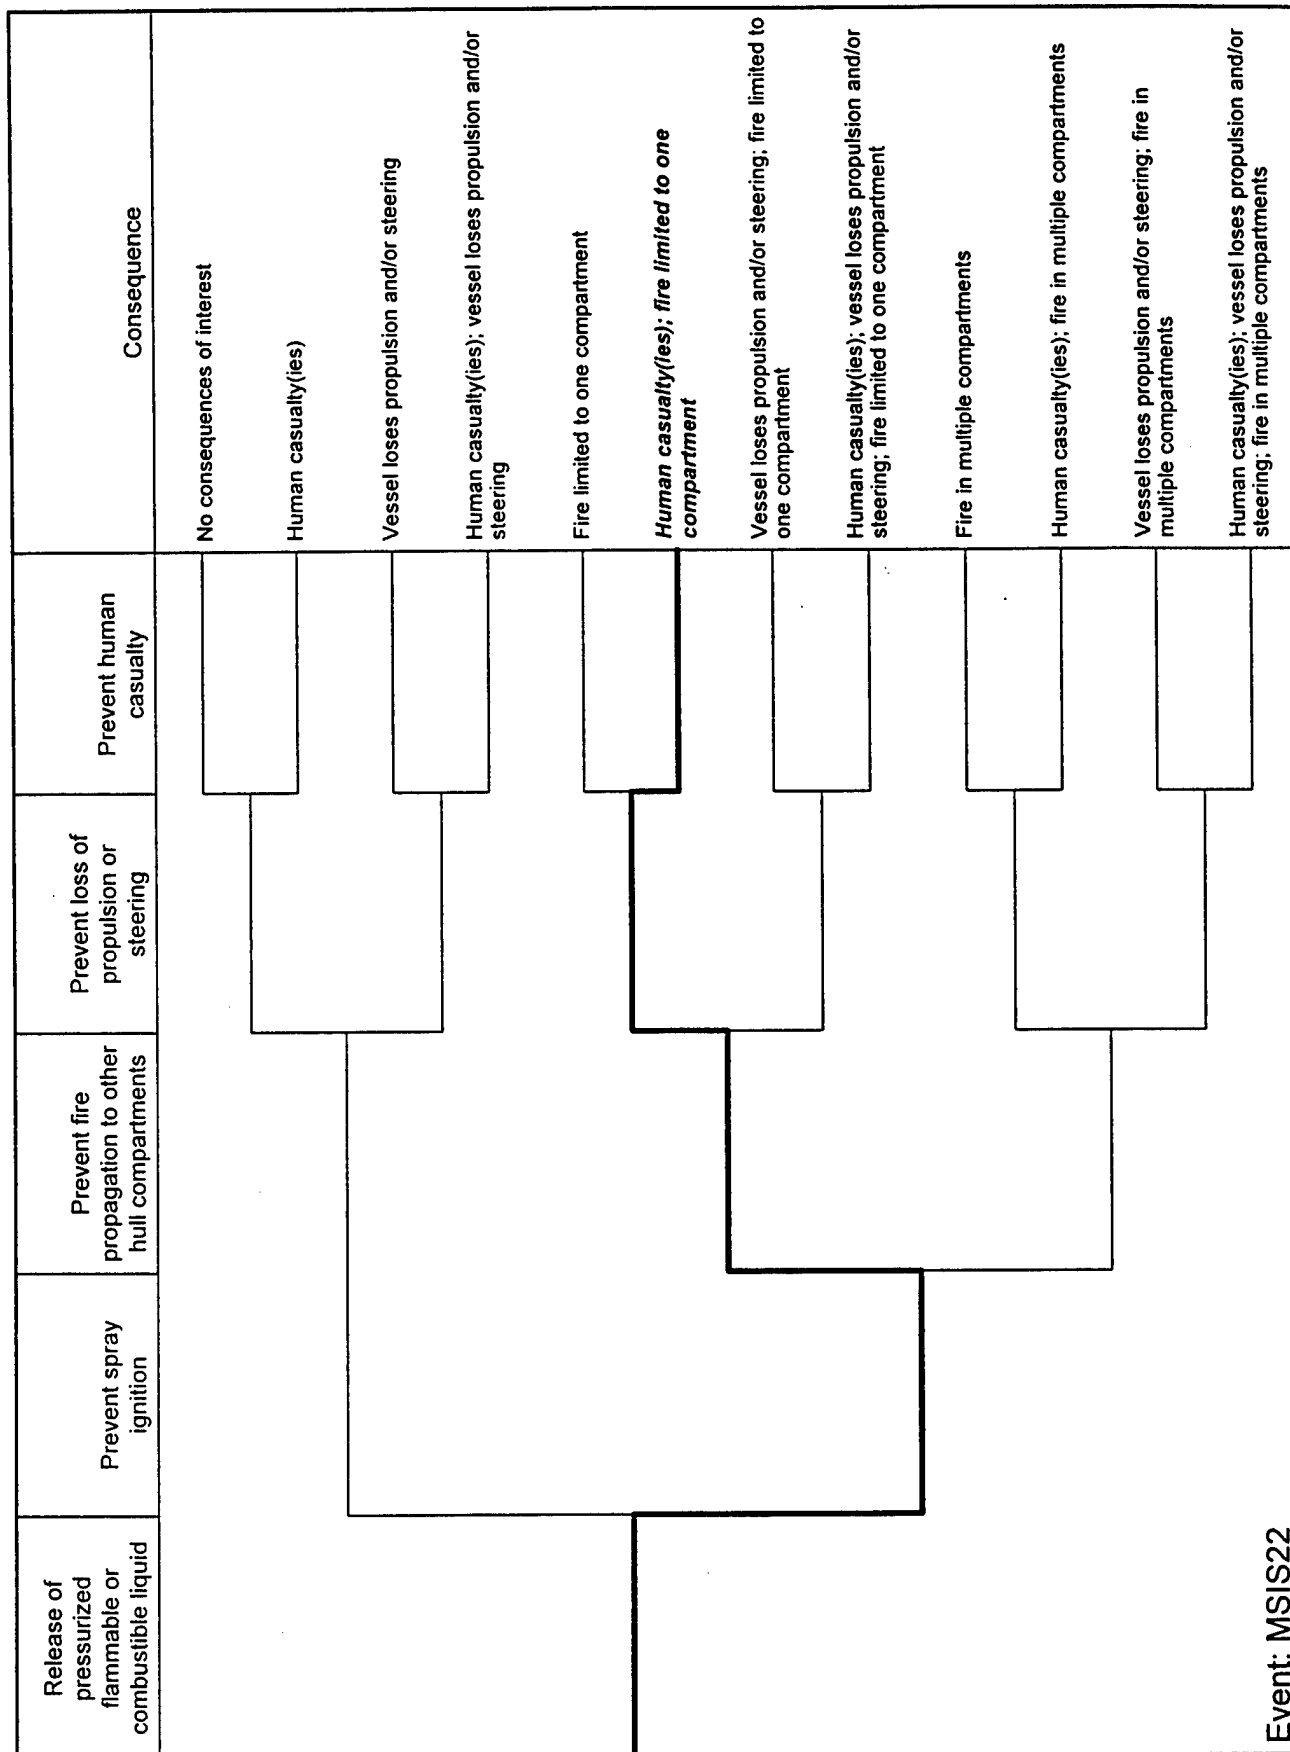
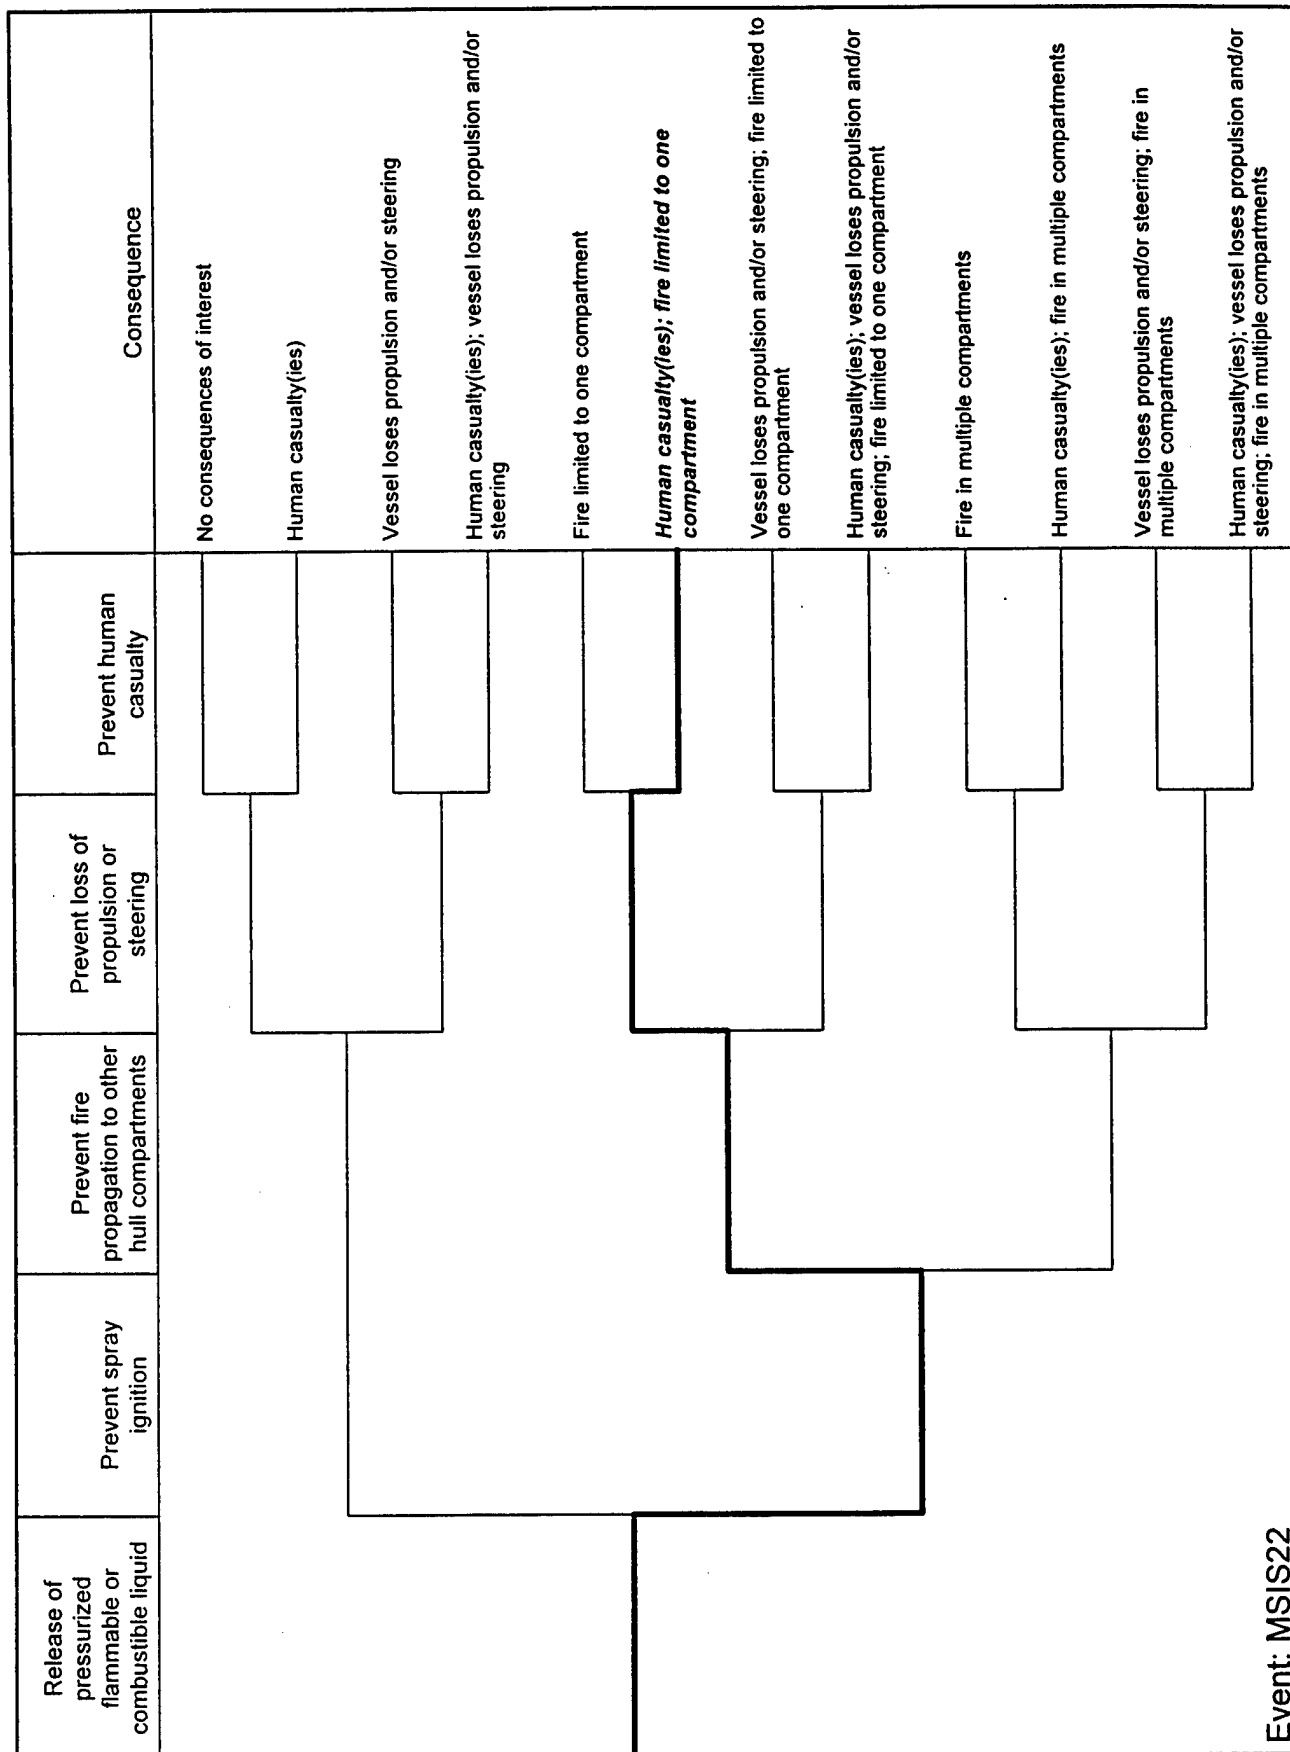
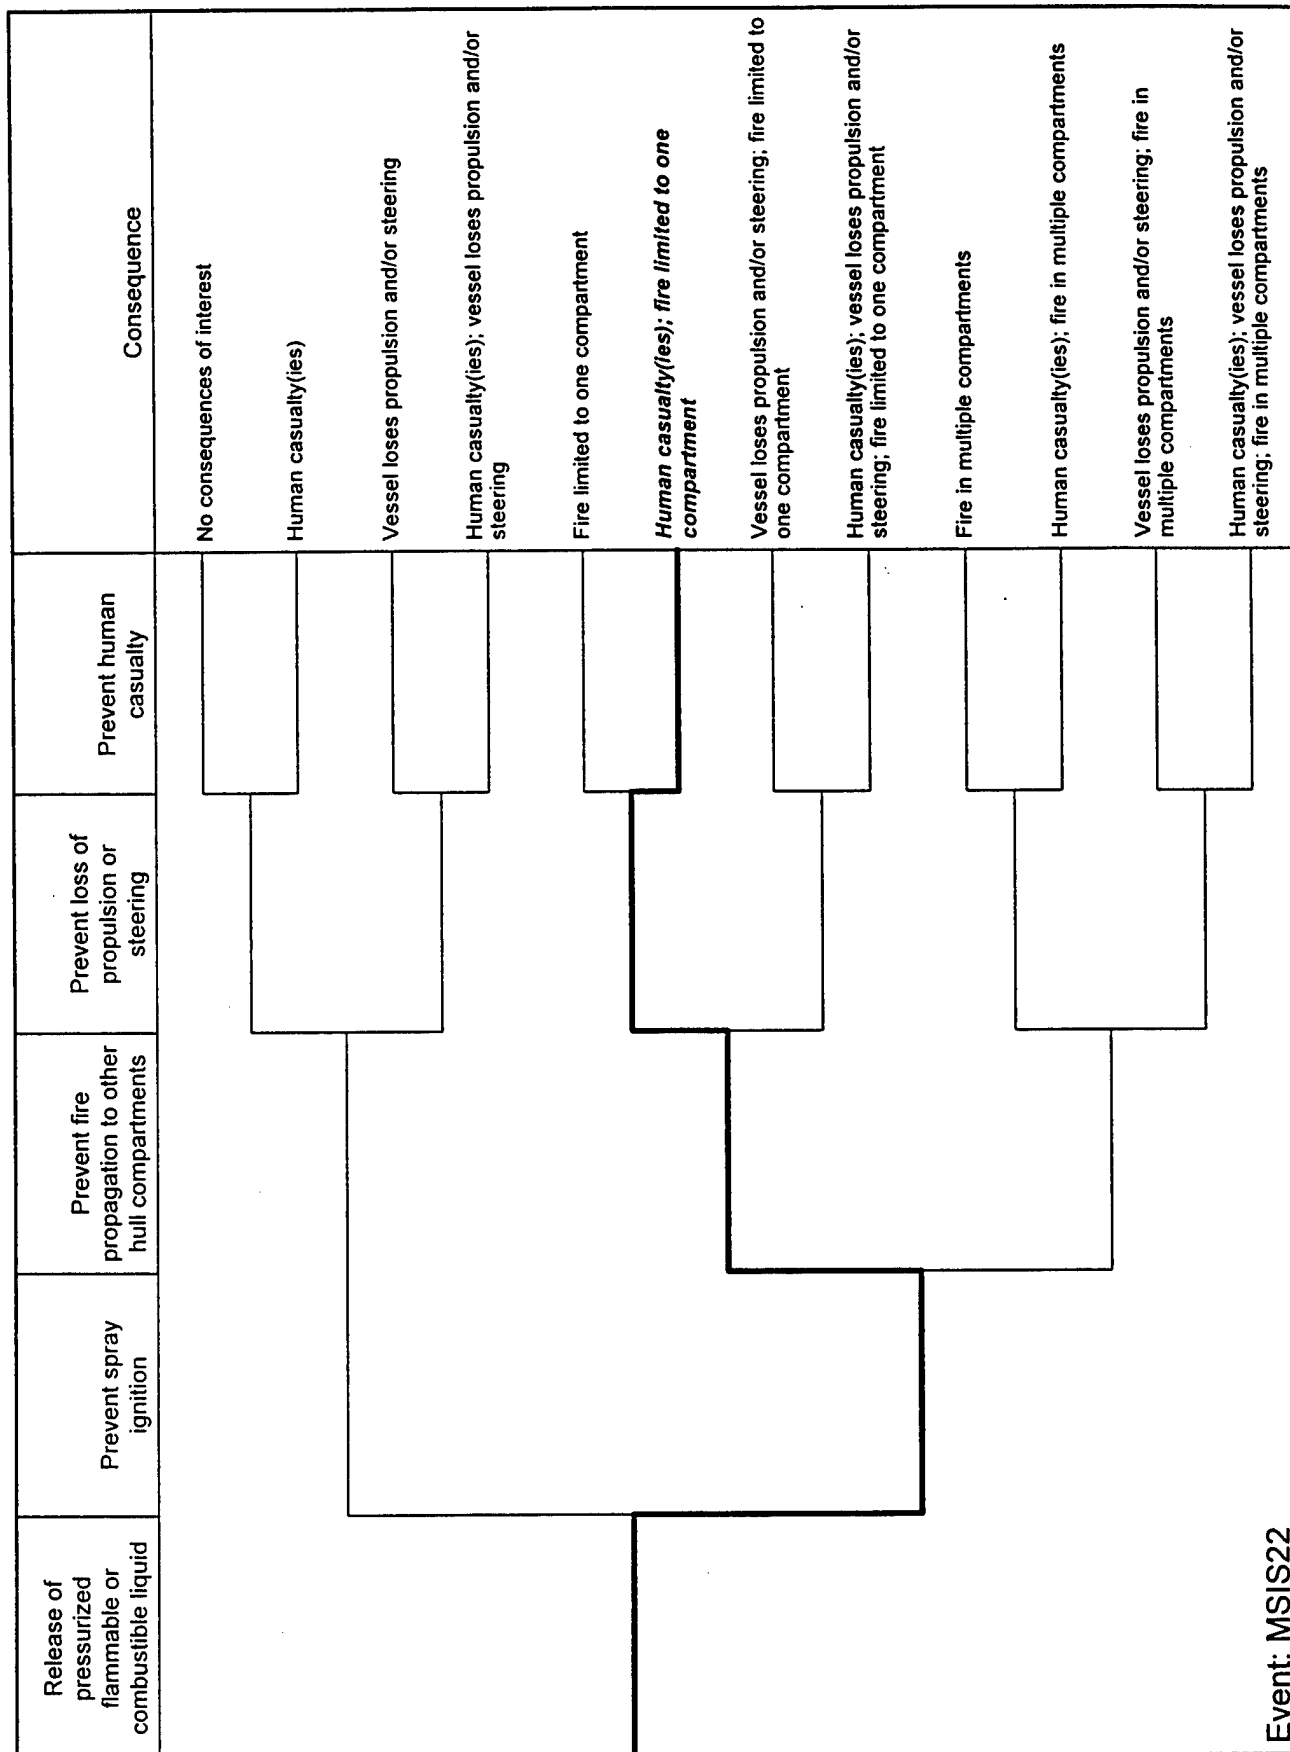
SNM WAS FLUSHING FUEL LINES TO CLEAN OUT BUNKER C OIL. HE WAS USING A TORCH TO HEAT VALVES TO LOOSEN SLUDGE PRODUCTS WHEN THE #2 DIESEL OIL BEING USED AS A SOLVENT SPRAYED FROM THE DRAIN VALVE HE WAS WORKING ON AND IGNITED, CAUSING THE VICTIM TO BECOME ENGULFED IN FLAMES OVER 80 PERCENT OF HIS BODY.
